ASTM B117 Salt Fog Test

The ASTM B117 Salt Fog test was performed in the Quality Assurance Lab at SunBelt Coating in Cleveland, TN. A coated hurricane tie was placed in the chamber and stayed there for 3,072 hours. After 2,064 hours, an uncoated hurricane tie was placed alongside it.

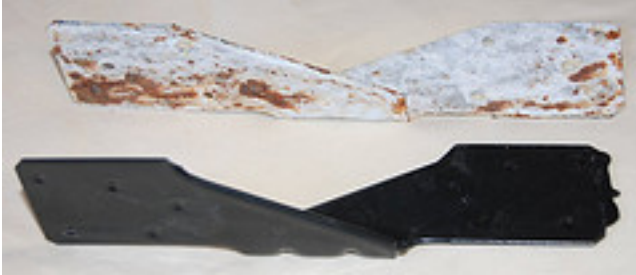
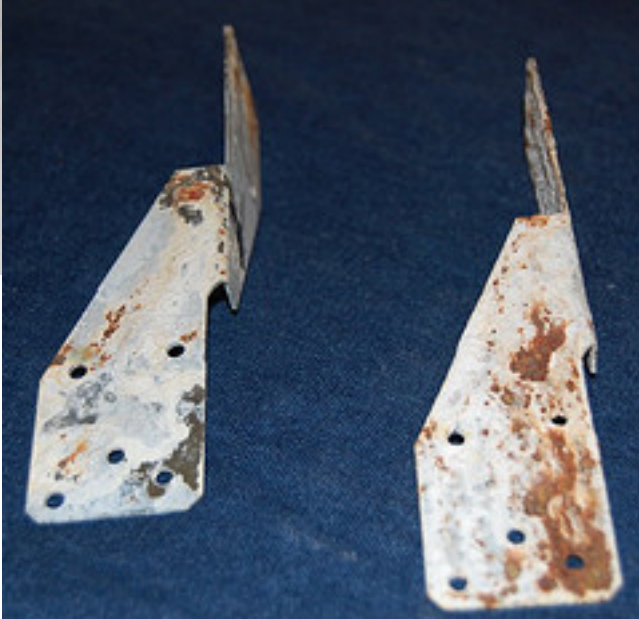
From the photos below, it is evident that, even though salt water was allowed to accumulate beneath the coating for 3,072 hours, the damage to the substrate was greatly reduced compared to the damage done to the uncoated tie in 1,008 hours.

In the photo on the right, the tie on the right was exposed for 1,008 hours. The tie on the left, which had been coated with Storm Greeter, was exposed for 3,072 hours. The advantage, even when Storm Greeter “failed”, is clear.

The method of placement of these ties involved inserting a plastic ring through an aperture in the tie. This necessitated making a hole in the Storm Greeter coating. Storm Greeter had been applied without priming the substrate because the intention was to peel the coating after the test.
