Alabama DOT Testing

In November of 2011, the Alabama Department of Transportation proposed a test of Storm Greeter in the bay at Perdido Pass, in Orange Beach, AL. A fourteen foot, 2.5 inch square sign post was coated inside and out with Storm Greeter and placed on a pier at the Marine Police Station. The post, along with a galvanized post, was bolted to a marine-grade wooden piling.

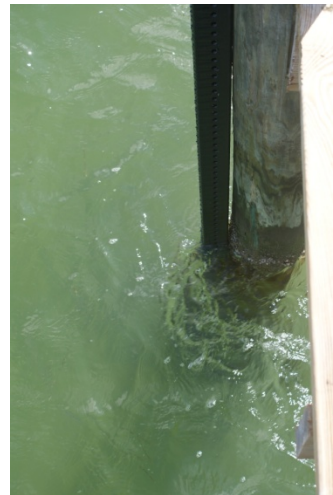
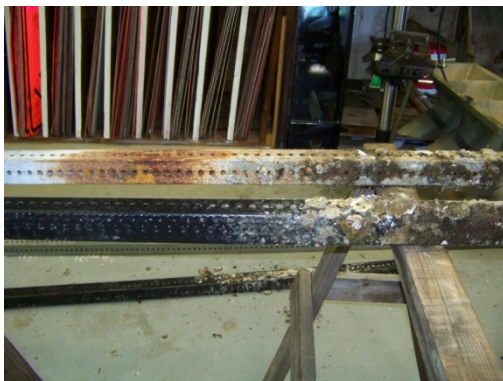
From the marine life in the photo on the left, it is easy to tell how the two posts were positioned in the seawater. Note the rust on the galvanized post, created in the splash zone, and the pristine condition of Storm Greeter in the same area.

The test ran for 13 months. At the 6 month point of the test, the posts were removed and six-inch sections were cut from the bottoms of each. This left a bare, galvanized edge on the Storm Greeter post. Over the next 7 months, the coating at the bottom edge did not delaminate.

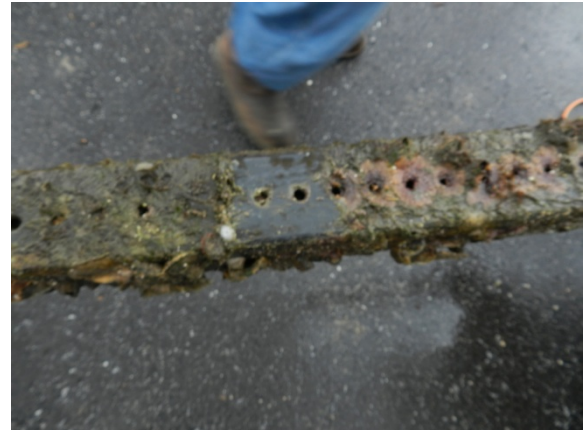
After 13 months in the bay, there was an abundance of marine life inside and out. The clear section on the Storm Greeter post is where the marine life was scraped away with the edge of a knife blade to expose the intact coating underneath.

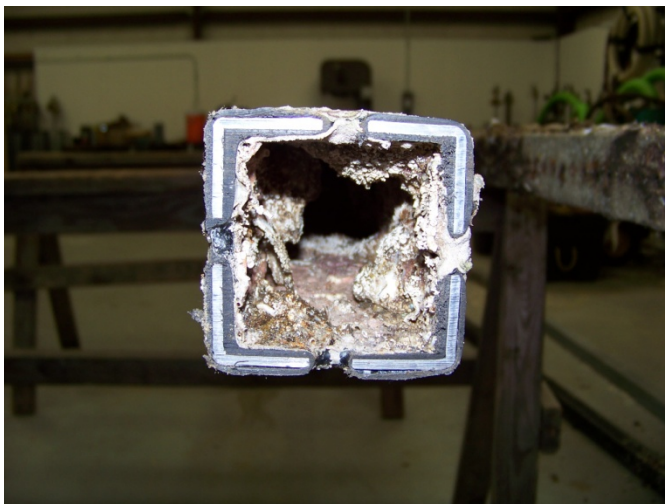
This cross-section shows the accumulation of marine life inside the post. The coating was not penetrated or damaged by the barnacles and other crustaceans.
