## Alabama DOT Testing

In November of 2011, the Alabama Department of Transportation proposed a test of Storm Greeter in the bay at Perdido Pass, in Orange Beach, AL. A fourteen foot, 2.5 inch square sign post was coated inside and out with Storm Greeter and placed on a pier at the Marine Police Station. The post, along with a galvanized post, was bolted to a marine-grade wooden piling.

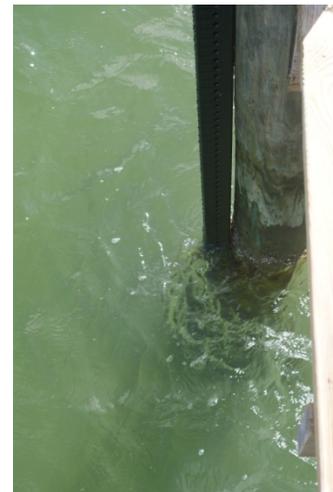
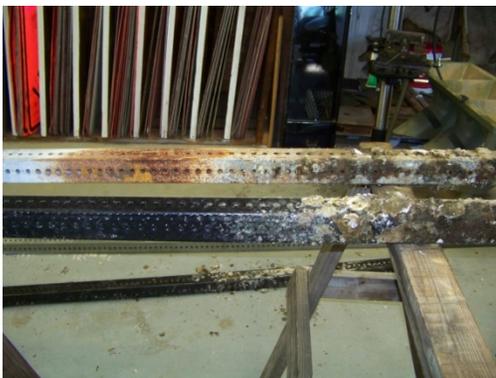
From the marine life in the photo on the left, it is easy to tell how the two posts were positioned in the seawater. Note the rust on the galvanized post, created in the splash zone, and the pristine condition of Storm Greeter in the same area.

After 13 months in the bay, there was an abundance of marine life inside and out. The clear section on the Storm Greeter post is where the marine life was scraped away with the edge of a knife blade to expose the intact coating underneath.

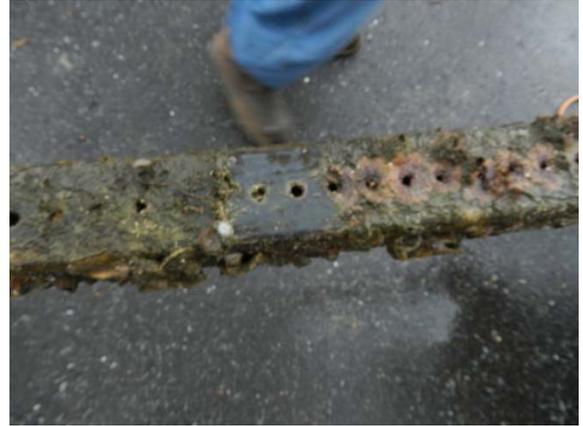
This cross-section on the left shows the accumulation of marine life inside the post. The coating was not penetrated or damaged by the barnacles and other crustaceans.

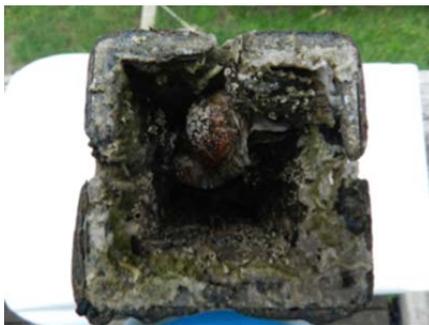
a. Fresh from the ocean

a. This is the bare steel end of the post after being exposed for 7 months to sea water and marine life.

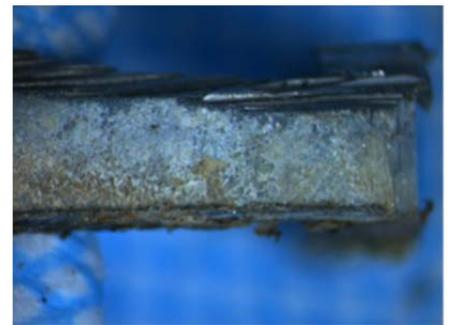
b. Facing edge, after 7 months' exposure to sea water

b. The Storm Greeter coating protected the facing edge of the steel. It did not delaminate.
