Storm Greeter - ASTM B117 "Salt Fog" Test Results

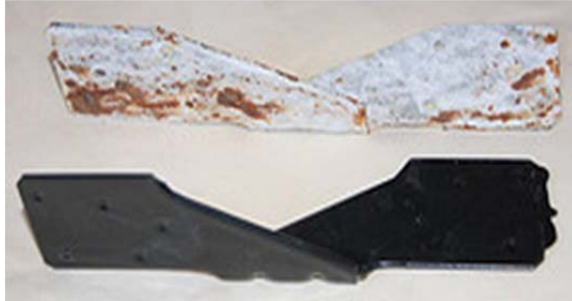
Fig. 1

Figure 1: Two galvanized hurricane ties were placed in a salt fog chamber to conduct the ASTM B117 test. The black tie is coated with Storm Greeter. It stayed in the chamber for 3,072 hours. The uncoated tie was in the chamber for 1,008 hours.

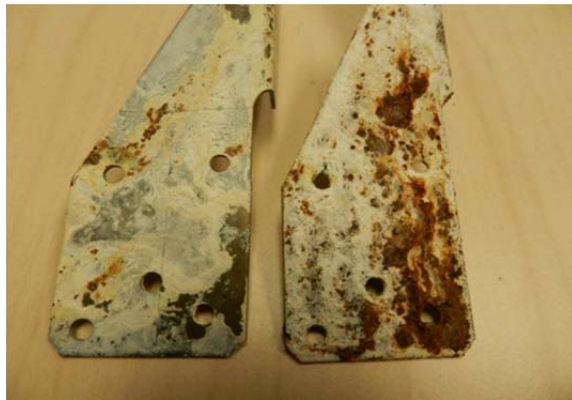
Fig. 2

Figure. 2: In order to hang the Storm Greeter tie in the chamber, a hole was made in the coating. Because the coating would need to be removed at the end of the test, the steel was not primed as it normally would be. During the 3,072 hours in the chamber, salt water was able to accumulate inside the coating. The photos show that, even though the Storm Greeter tie was in the salt fog chamber more than 3 times as long as the uncoated tie, with a hole in the coating, the amount of red rust is much less than on the uncoated tie, showing that the Storm Greeter coating greatly reduced the damage done by the ASTM B117.

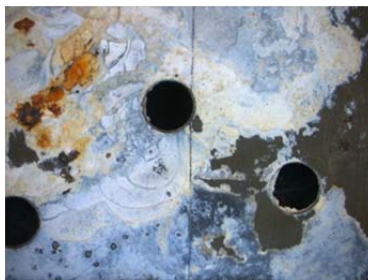
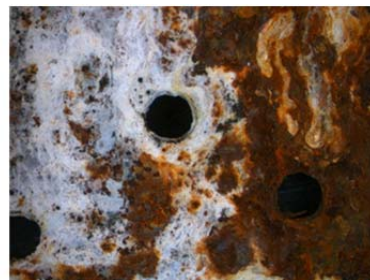
Post-Test: A close-up photo of the ties before cleaning. The Storm Greeter tie is on the left,...

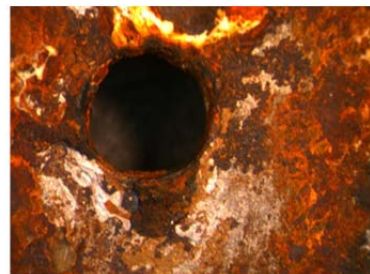
and a further magnification of the ties after scrubbing and cleaning with acetone.
