## ASTM B117 "Salt Fog" Test Results - ecomère

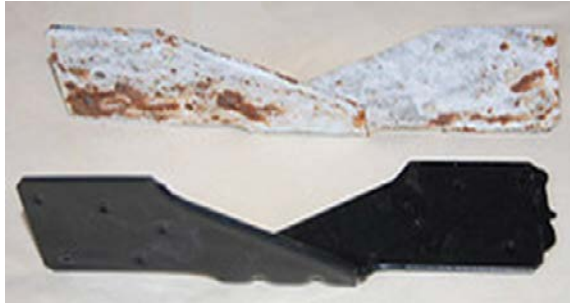
Fig. 1

**Figure 1:** Two galvanized hurricane ties were placed in a salt fog chamber to conduct the ASTM B117 test. The black tie is coated with **ecomère**. It stayed in the chamber for 3,072 hours. The uncoated tie was in the chamber for 1,008 hours.

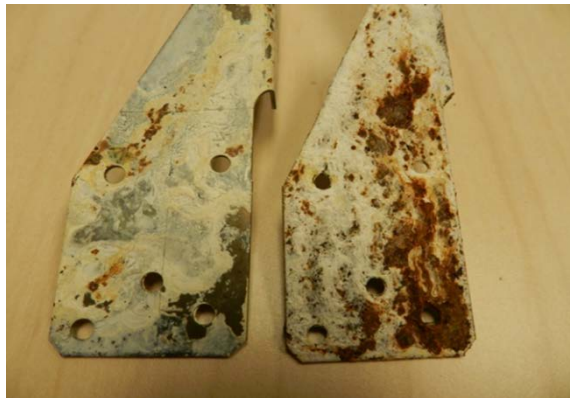
Fig. 2

**Figure 2:** In order to hang the **ecomère** tie in the chamber, a hole was made in the coating. Because the coating would need to be removed at the end of the test, the steel was not primed as it normally would be. During the 3,072 hours in the chamber, salt water was able to accumulate inside the coating. The photos show that, even though the **ecomère** tie was in the salt fog chamber more than 3 times as long as the uncoated tie, with a hole in the coating, the amount of red rust is much less than on the uncoated tie, showing that the **ecomère** coating greatly reduced the damage done by the ASTM B117.

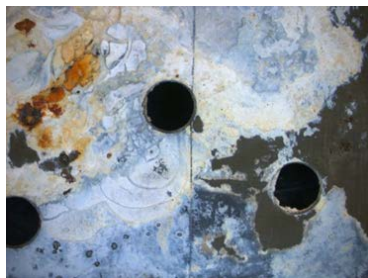
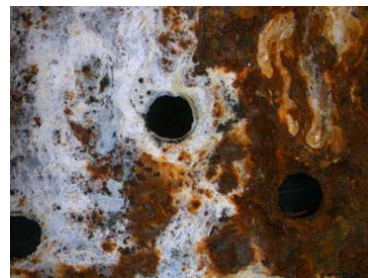
Post-Test: A close-up photo of the ties before cleaning. The **ecomère** tie is on the left,...

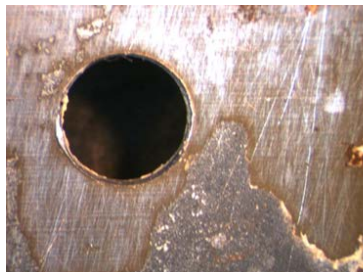
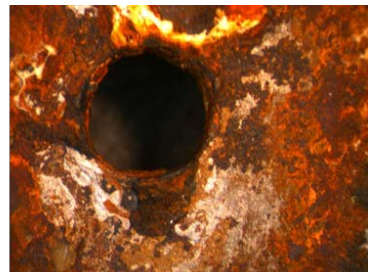
and a further magnification of the ties after scrubbing and cleaning with acetone.
